ADVISORY CIRCULAR 43-16A

AVIATION MAINTENANCE ALERTS

ALERT
NUMBER
277

AUGUST
2001

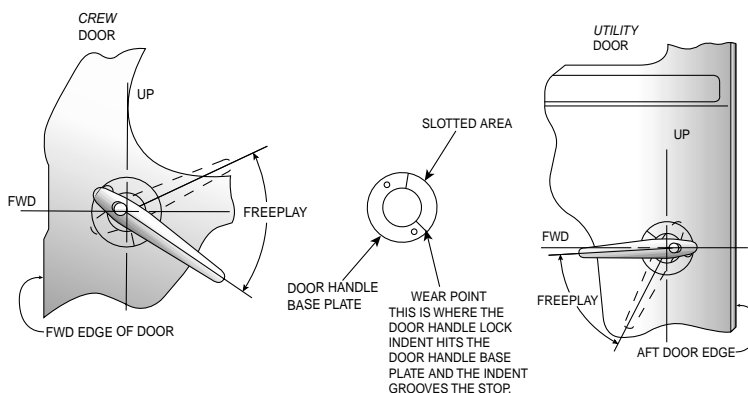
If the door handles are not installed correctly, the cabin side door or utility door can be inadvertently opened from the inside without depressing the handle lock release button. The handle lock release button is designed to prevent unintentional opening of these doors. Airworthiness Directive (AD) 97-14-15 was written to correct improper reinstallation of the door handles; however, incorrect reinstallations still occur.

The illustrations show the correct installation of a cabin side door and a utility door lock.

The submitter of this report recommended that after door handle removal, or as required by the manufacturer's technical data, that a check of both the cabin side door handle and the utility door handle be accomplished in accordance with the latest revision of SB 2693. The inspections of the door handle installations are to be accomplished by a certificated airframe mechanic or certificated pilot as required by Federal Aviation Regulations. Inspection of the interior door handle is now included as part of the 100-hour inspection in the shop manual for Models 55 and 58 aircraft. In accordance with AD 97-14-15, all airplanes must be inspected after 50 hours time-in-service (TIS). Regular maintenance should identify incorrectly installed door handles.

If the door handle opens the door when rotated, without depressing the handle's lock release button, prior to further flight, correct the door handle lock by removing the door handle, and reinstalling the door handle so that the lock release button locks the door in accordance with SB 2693.

If the door handle is locked and will only unlock by depressing the handle door lock release button, then no further action is necessary.

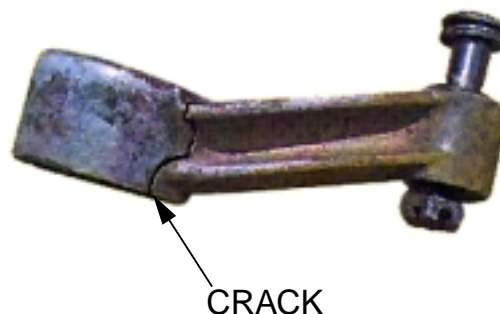
While investigating this incident, a technician discovered the landing gear crank arm (P/N 35-825174) was cracked. (Refer to the illustration.) The gear crank arm attaches to the landing gear transmission, and the crack allowed it to expand and rotate on the transmission shaft splines.

The submitter speculated the weight of the nose gear applied pressure to the push-pull rod and caused the crank arm to rotate and release the nose gear. Metal fatigue is the most probable cause for this failure. He recommended removing the crank arm for a one-time inspection and using a 10X magnifying glass to check for evidence of cracking or slippage on the splines. The same landing gear arrangement is used on many other Beech aircraft models, and the cranks arm deserves your full attention during inspections and maintenance.

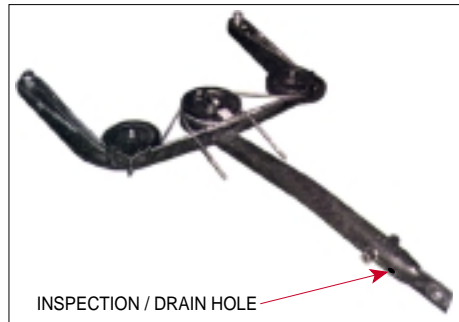
The elevator control yoke (P/N 0560014-5) was “full of rusty water,” and the interior of the tube assembly was severely corroded. Failure of the control yoke would result in complete loss of elevator control and possibly a catastrophic accident.

SEB-01-3 allows drilling a hole in the elevator control yoke tubing for recurring inspections and drainage. (Refer to the illustration.) When the inspection/drain hole was drilled in the control yoke tube, the “rusty water” poured out.

The submitter urged all operators of like aircraft to comply with SEB-01-3 and suggested that the data be used for an Airworthiness Directive.

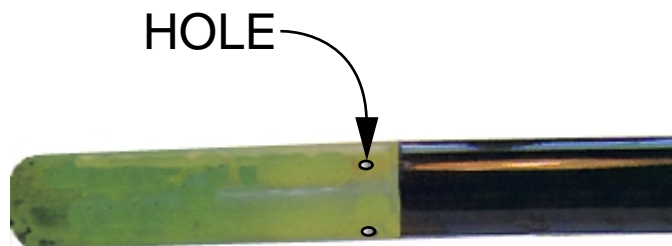
The technician ordered a new stabilator counterbalance arm tube (P/N 69623-004) from Piper. When the part arrived, he conducted a receiving inspection and found an extraneous hole in the tube. The hole was positioned at 90-degrees to the normal fastener hole and appeared to be filled with "slag." Also, "slag" was present on the interior of the tube. He speculated the "slag" was deposited when the part was fabricated.

The extra hole was located at a critical high stress point on the tube, and the submitter considered it to be structurally unairworthy. When received, a thick coat of black paint and zinc chromate covered the extra hole. After removing the paint, it appeared the extra hole had been filled with an unknown type of material. (Refer to the illustration.) The submitter suggested that technicians inspect all incoming parts for similar defects.

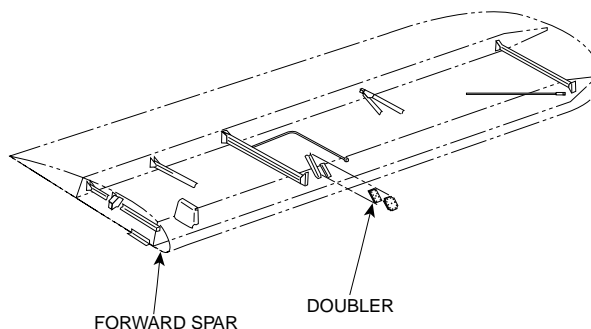
The technician found the corrosion damage after drilling off a reinforcement plate/doubler. The corrosion was located between the doubler (P/N64188-00) and the rear face of the forward wing spar (P/N 64055-06). (Refer to the illustration.) The submitter suspects the corrosion was caused by moisture “wicking” in between the doubler and the spar.

The submitter suggested yearly treatment of the doubler-spar interface with a corrosion preventive product. This area is normally inspected only when the fabric covering is replaced.

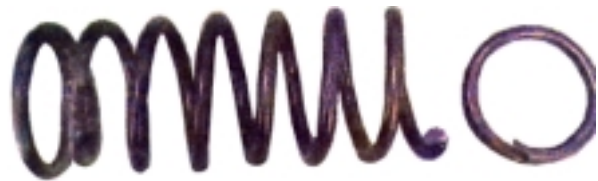
When the shop technician disassembled the propeller for overhaul, he discovered the feathering spring (P/N B1594-1) was broken. The fracture surfaces of the broken spring displayed evidence that the failure was caused by a pre-existing crack that had occurred some time ago. The spring was broken between the first and second coil and evidence of corrosion was present. (Refer to the illustration.)

The submitter speculated the crack originated from the corrosion and progressed over time to the failure point.
